# Convection Cooled Bridges Offer New Solution to Old Alterrex Water-Cooled Bridges

By Raj R. Patel, Exelon Power, and Richard C. Schaefer, Basler Electric

*The Exelon Power Mountain Creek Generating Station in Dallas, Texas, is one of many plants faced with continuing repair and the decision of replacing the existing water cooled Alterrex bridges. This paper describes the decision process that was involved in the actual bridge replacement, the testing, the install and the commissioning of the new system.*

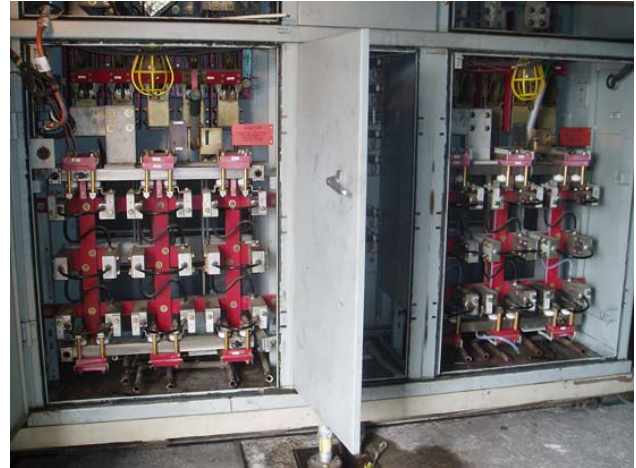
Mountain Creek Unit # 8 is rated for 583 MW, 22 kV, 3600 RPM with rotor field requirements of 4600 Amps. Over the years, the Alterrex water cooled bridges developed recurring water leaks which required repair by removing the bridge from the doghouse. The existing system consists of four (4) water cooled bridges, two on each side of the generator doghouse. See Figure 1. Each bridge consists of 12 rectifier hockey pucks mounted on a heatsink and supplied with snubber circuits that are water cooled via copper and Teflon tubing that carries deionized water from the stator cooling reservoir.

Figure 1. Old Water-Cooled Bridges

Each bridge contains a "No Load Break Disconnect" switch and a neon light panel to display any fail diode within the bridge. The disconnect switch provided the means to remove the ailing bridge from the system for repair. Where the OEM instruction manual suggests not opening the rectifier switch while the system is operating, it is common practice in most systems to open the switch with the bridge in operation.

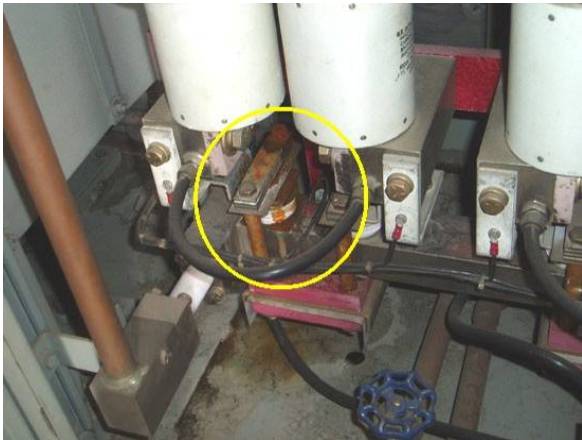
On the Southeast corner of the generator doghouse, a major leak on the water cooled rectifier bank was occurring, resulting in 20 drops per second. Operations had isolated the bank and taken it out of service. Since the system is a N+1 design, one out of four rectifier banks could be removed from service. Yet, there was one more water leak on the Southwest corner rectifier bank. The concern was that if the leak got worse like the Southeast leaking bridge, a total of two banks would be out of service, and that would require a derating of the machine MW output. Figure 2 shows corrosion track across the diode from the leaking water.

Figure 2. Corrosion tracking of leaking water

The OEM did not recommend fixing these water leaks in the field. They recommended removing the bridge and sending the leaking bridges to a licensed service shop that could repair and provide

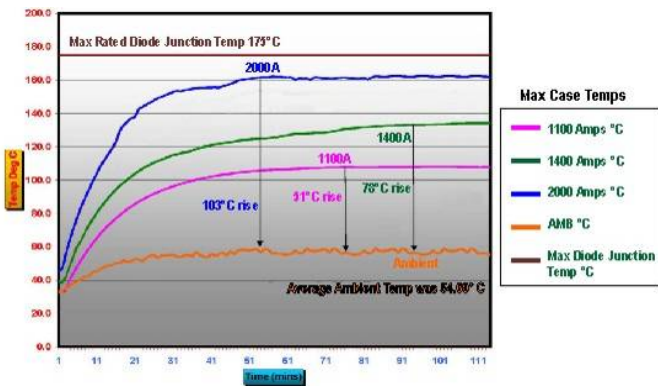
Figure 5. Temperature rise at Various Current Levels of a Single Bridge in Parallel with other Rectifier Bridges

Figures 18 and 19 highlight performance data of Mountain Creek #8 SW Bank #4 operating at full load Rated Power Factor on one of the four rectifier bridges. In Figure 17, the rectifier current for each of the four bridges is 760 A DC, where the maximum rating of each bridge is 2000 A DC. Referencing back to Figure 5 temperature data graph, where a bridge is operating at approximately 800 Amps, the expected total temperature of the bridge would be about 90 degrees C for a 50 degrees C ambient temperature. Note in Figure 19 how closely the actual temperature being measured correlates with the expected performance goals for Figure 5.

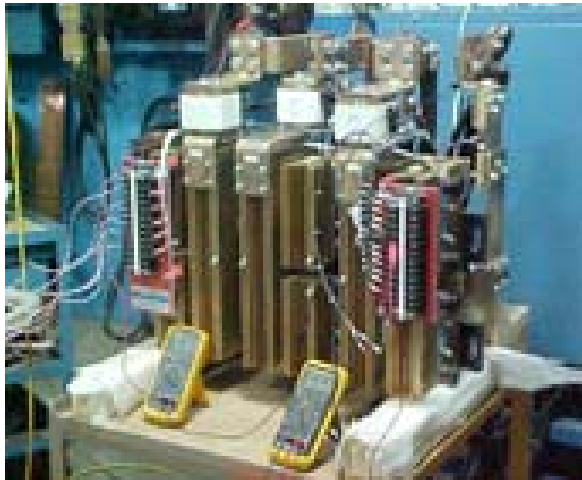
coordinated with the outage schedule. Prior to shipment, the bridges were heat run tested at the factory for 2000 amperes until the temperature stabilized after approximately two (2) hours. The test applied full rated current at a reduced voltage to all four (4) bridges connected in parallel. See Figure 6. The importance of this test was to provide confidence in the bridges operating at the rated current, since Mountain Creek Unit #8 would not be at full capacity until a much later time in summer

Figure 6. Test Setup of 2000 Ampere Heat Run

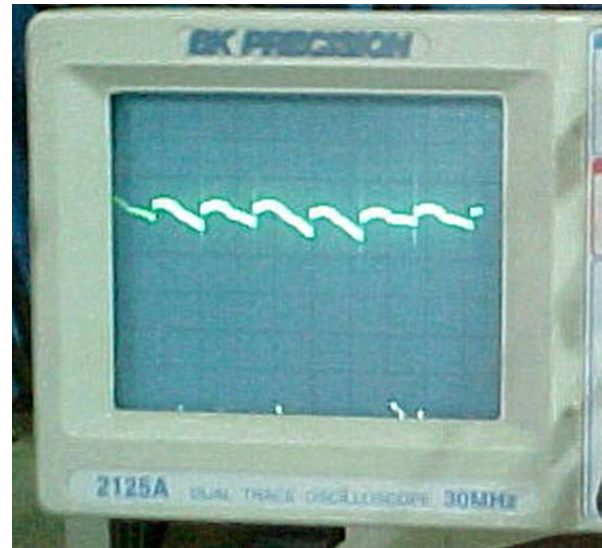
peak load season after the outage. Table 2 provides a sample of the starting temperature and final temperature of one of the tested rectifier bridges. Besides the full current capacity test, oscilloscope waveform information was gathered to verify that the diode bridge was at 100% conduction. Data shows 2.8 ms between each peak for a three phase full wave bridge. See Figure 7.

Figure 7. Three Phase Full Wave Bridge Output Waveform

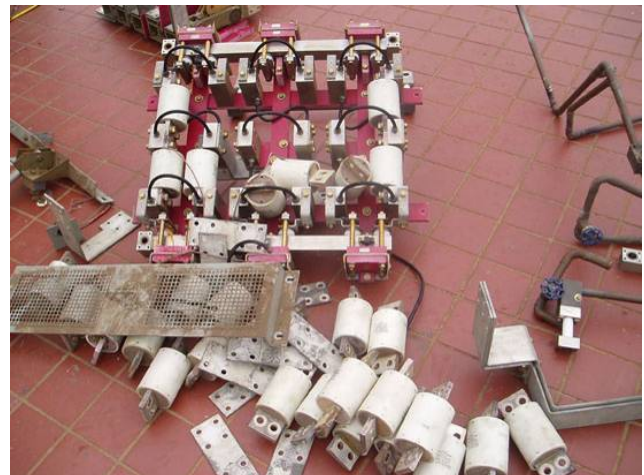
The new bridges were received with a certified test report from the manufacturer. The outage lasted for 7 days, and a four-man team from a local electrical contractor was assigned for the tearout and install of the new bridges. The demolition began on Saturday; it took one day to remove the copper water lines, the rectifier bridges, knife switches, and to cap the incoming water lines. The resultant demolition was a huge pile of fuses, bridges, and switches as space was prepared for the new hardware. The tearout was fast and expedient. See Figure 8 for sample of removed hardware.

Figure 8. Old disconnect switch and fuses removed

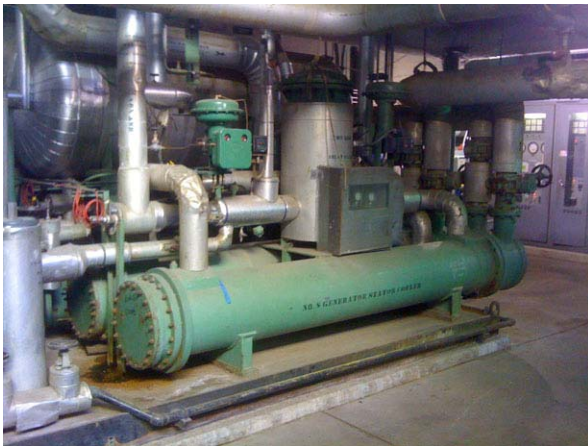
Figure 9 shows a photograph of the Stator and Alterrex deionized water cooling system. The new convection cooled Alterrex bridges eliminated the need for water lines going to the Alterrex doghouse located at the back of the generator housing. The "In" and "Out" water lines going to the Alterrex bridges were abandoned and capped, hence eliminating maintenance issues involving false field grounds and leaky water hoses. The results of these changes were improved reliability and reduced downtime.

Since water was no longer required for the new convection cooled bridges, the water cooling system provided increased availability of deionized water for the generator stator cooling system.

Figure 9. Generator Stator and Cooling Water System, Alterrex "In" and "Out" water lines are capped for retrofit to new Convection Cooled 2000 Amp Bridge System.

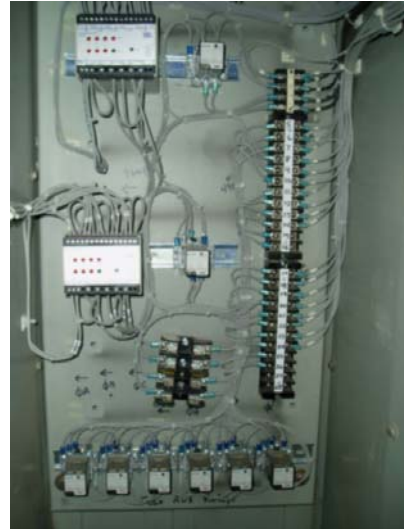
At time of installation, it was decided to have additional indication of the semiconductor fuse monitor and RTD relay. Here, four (4) relays were added, one for each fuse lamp indicator, one for the

RTD relay and one for the disconnect switch disposition. Since the panel to contain this requirement was decided at time of install, two days were spent creating the panel and wiring it into the available space. See Figure 10.

Figure 10. Temperature Relays and Remote Annunciation

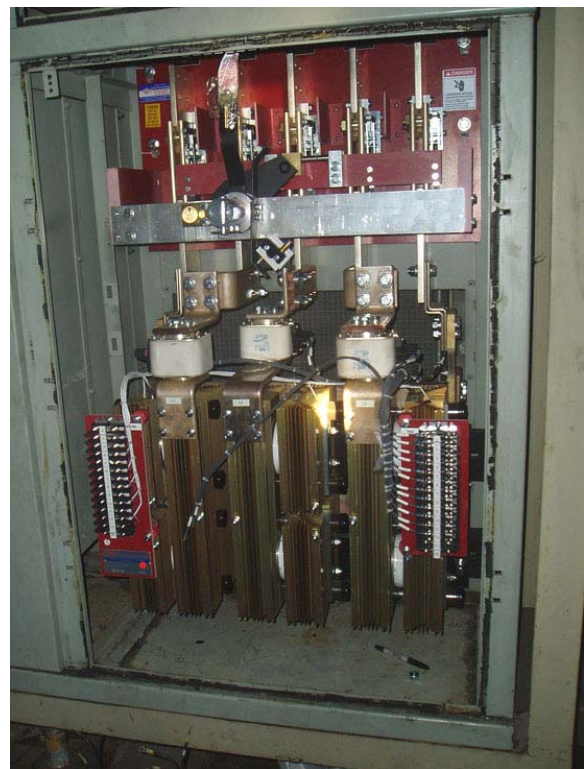
Figure 11. New Bolt Action Disconnect Switch and Convection Cooled Bridge

Shortly after the demolition was complete, the installation of the new convection cooled bridges and new switches commenced. The drop-in air cooled bridges were located into the same mounting holes as the previous bridges. The new disconnect switch mounted above the new rectifier bridge using the same mountings as the previous hardware. A shipped-loose symmetrical three phase snubber circuit consisting of three power resistors and three industrial grade oil filled capacitors connected across the each power diode. The snubber circuit provided a means to eliminate switching harmonics caused by diode commutation.

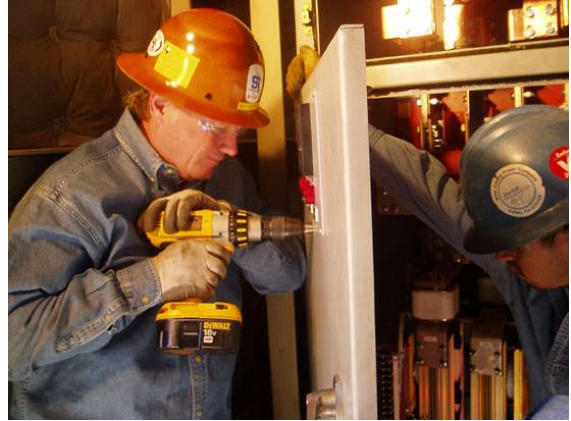
To allow the new disconnect switch to be opened with the door closed, a center hole was drilled using a template measurement scale. See Figure 14.

Figure 14. Center Hole for Outside Disconnect Switch drilled by local electrical contractor Technician Sermco Industries

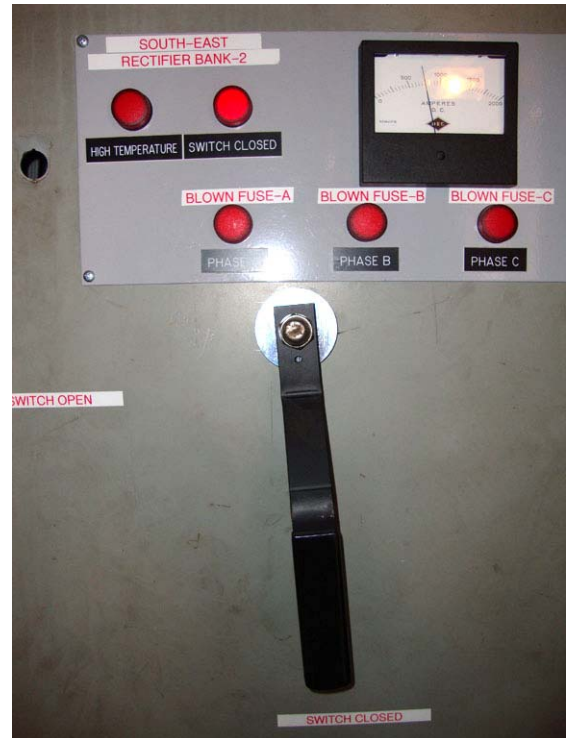
A new Alarm Panel was installed for the front of each enclosure door which included an Ammeter, three (3) status lights for fail semiconductor fuse indication, One lamp for High Temperature Alarm, and one lamp for Disconnect Switch Status. See Figure 15.

Figure 15. Display Alarm Panel and Hand Disconnect Switch

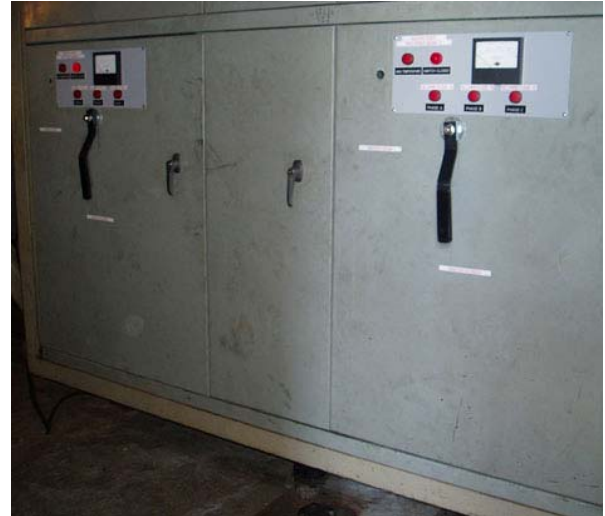
On Saturday, the eighth day of the outage, the install was complete and the equipment was released back to the plant. See Figure 16. After Unit #8 was released, some time later full load operation occurred, and the RTD relays were calibrated, based upon collected operating temperature of the bridges. Final calibration for the RTD relays was set for 125 °C temperature. Any higher temperature would alarm, indicating excessive bridge thermal conductivity. Figures 15 and 16 show front views of the “Extended outside handle for the “Disconnect Switch Operation” with the front panel meter display.

Figure 16. System Line-up of the SW Panels with Rectifier Panel Doors Closed
